DONALDSON COAL PTY LTD ABN: 87 073 088 945

Annual Environmental Management Report

Abel Underground Coal Mine 1 June 2009 to 31 May 2010

Ref No. 737/05

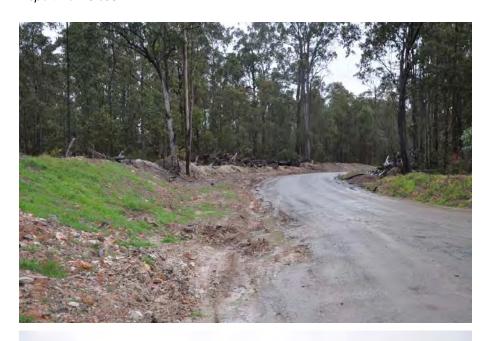
Plate 1 View east across the widened substation access road (Date of Photography 10 August 2010)

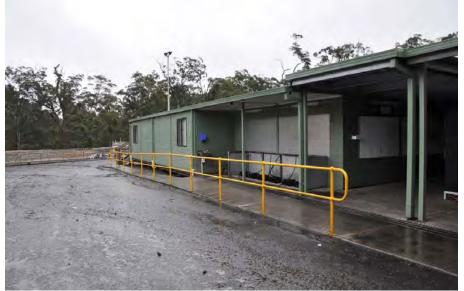
(Ref E737C_002)

Plate 2 New Safety & Training and Administration Building (Date of Photography 10 August 2010)

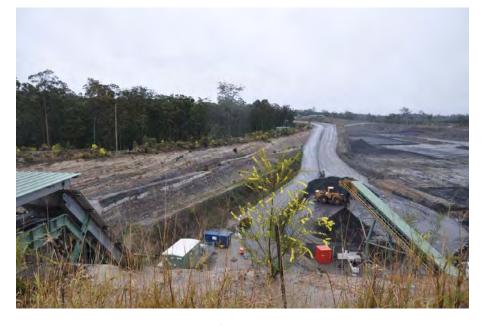
(Ref E737C_034)

Plate 3 View north over portal and coal handling area (Date of Photography 10 August 2010)

All ROM coal was stockpiled within the mine's portal and coal handling area (see **Plate 3**). The ROM stockpile, which is situated under the conveyor outfeed, has a capacity of approximately 3000t. During the reporting period, ROM coal continued to be transported to the Bloomfield CHPP by private road.
