**ABEL MINE**

**Hunter Water Corporation  
Water Pipeline Subsidence Management Plan**

**SMP Area 1  
East Mains Headings**

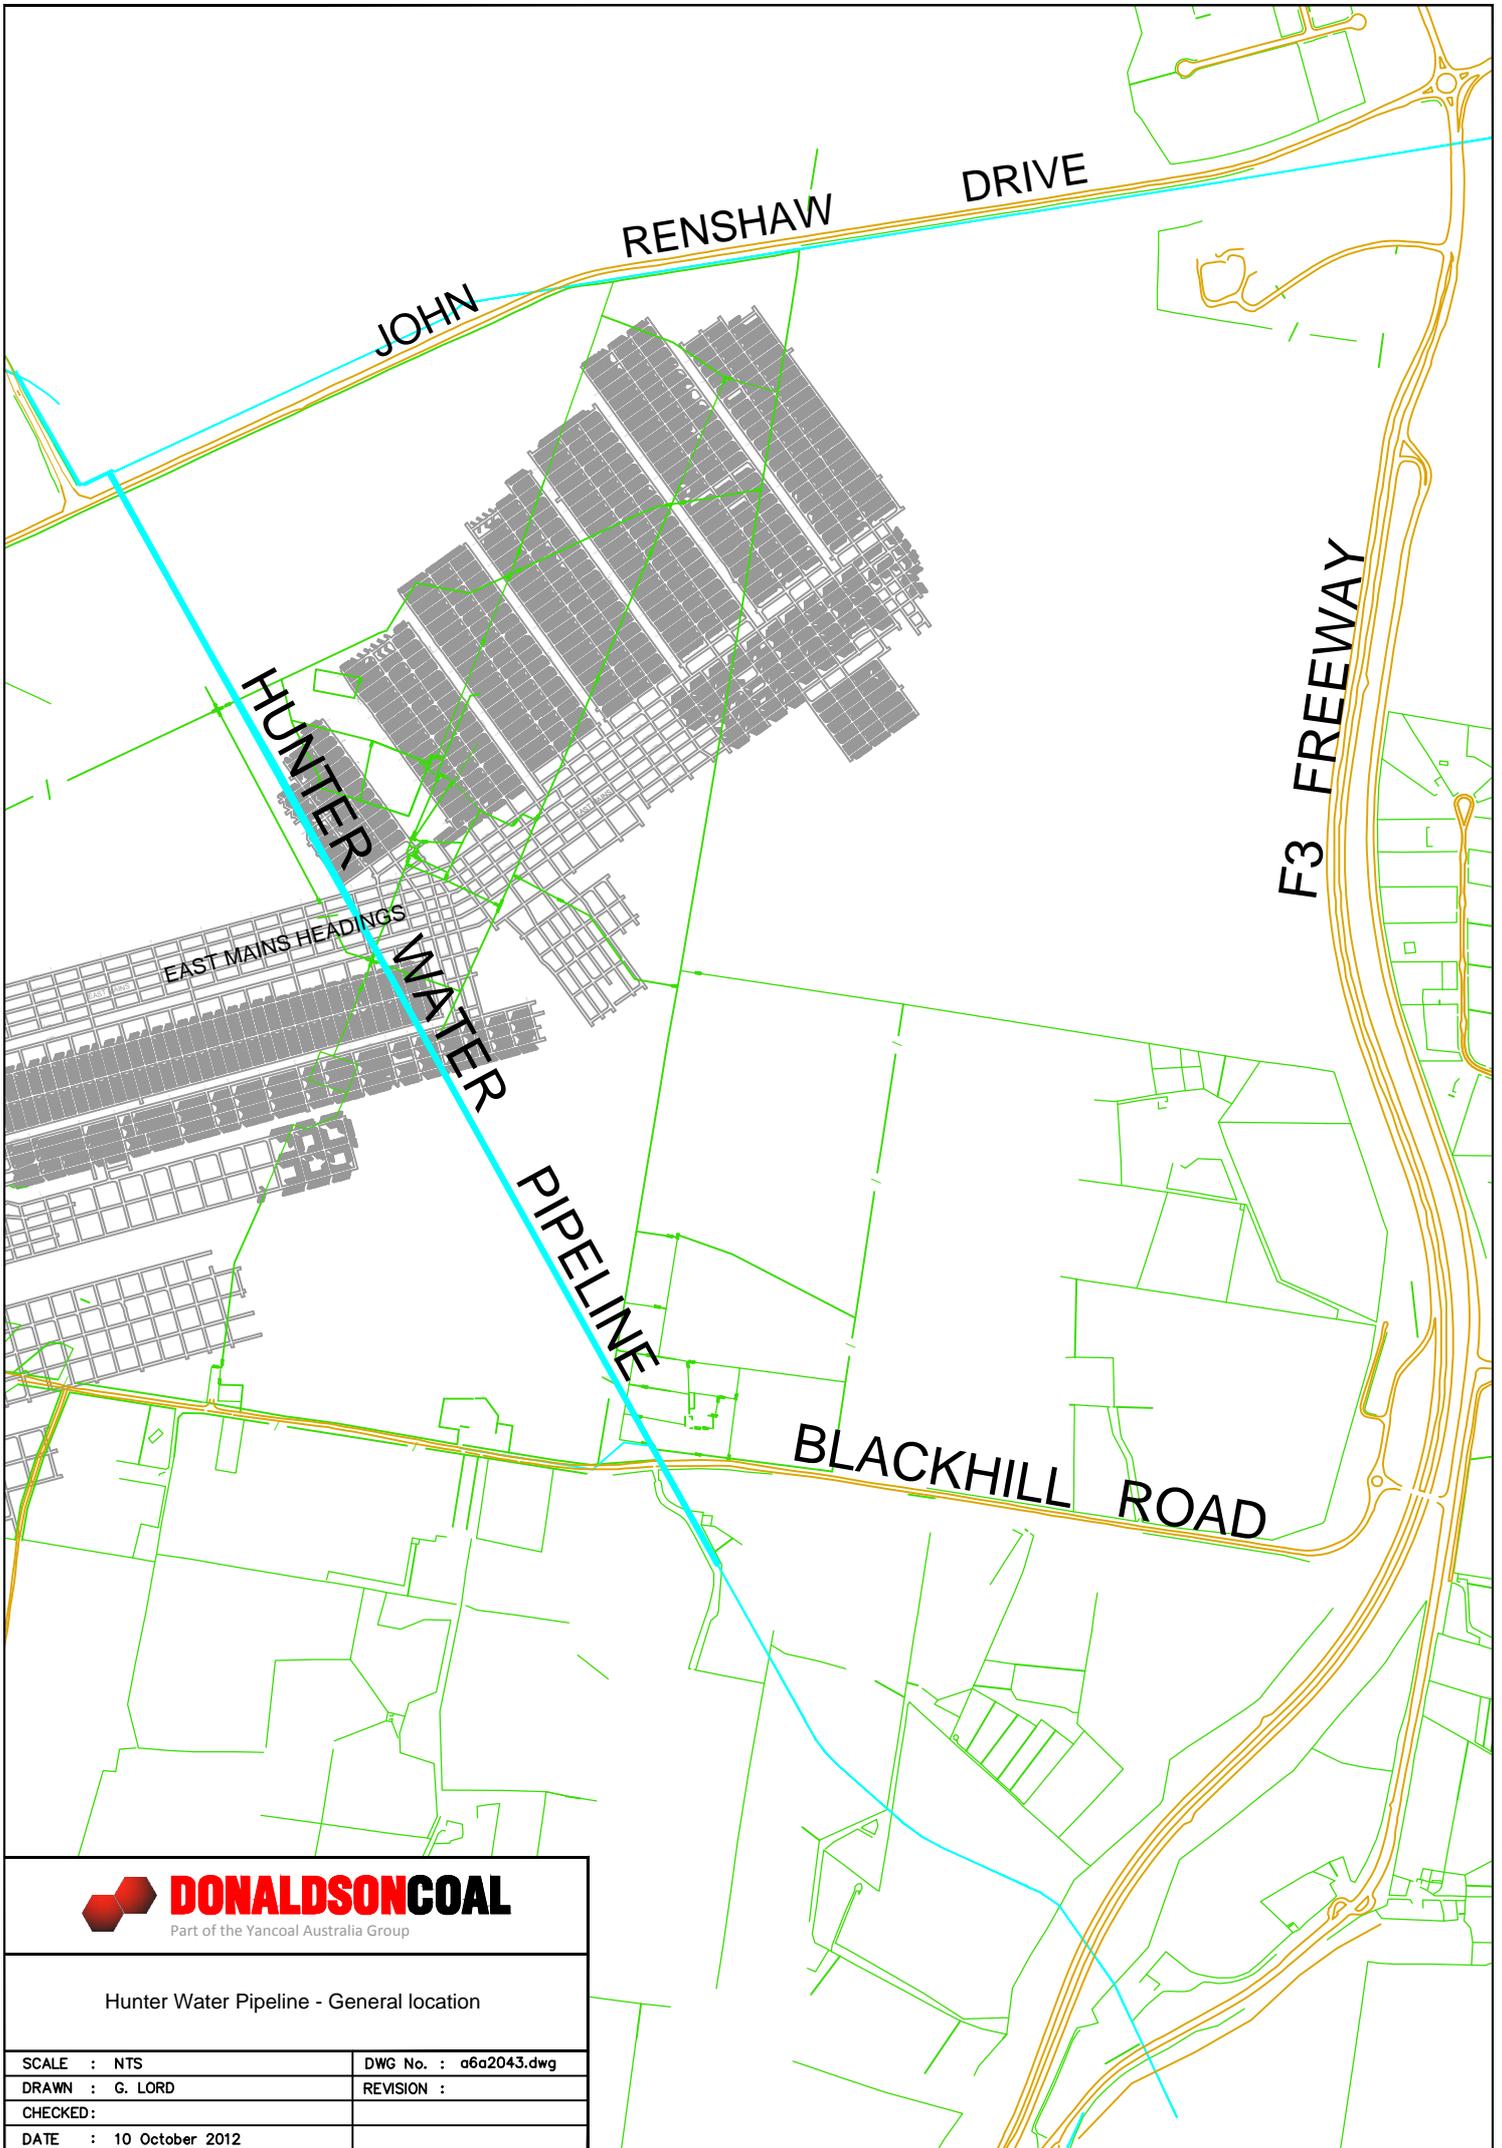
Hunter Water Pipeline - General location

Figure 1 - General Location of HWC Water Pipeline above East Mains Headings..... 6

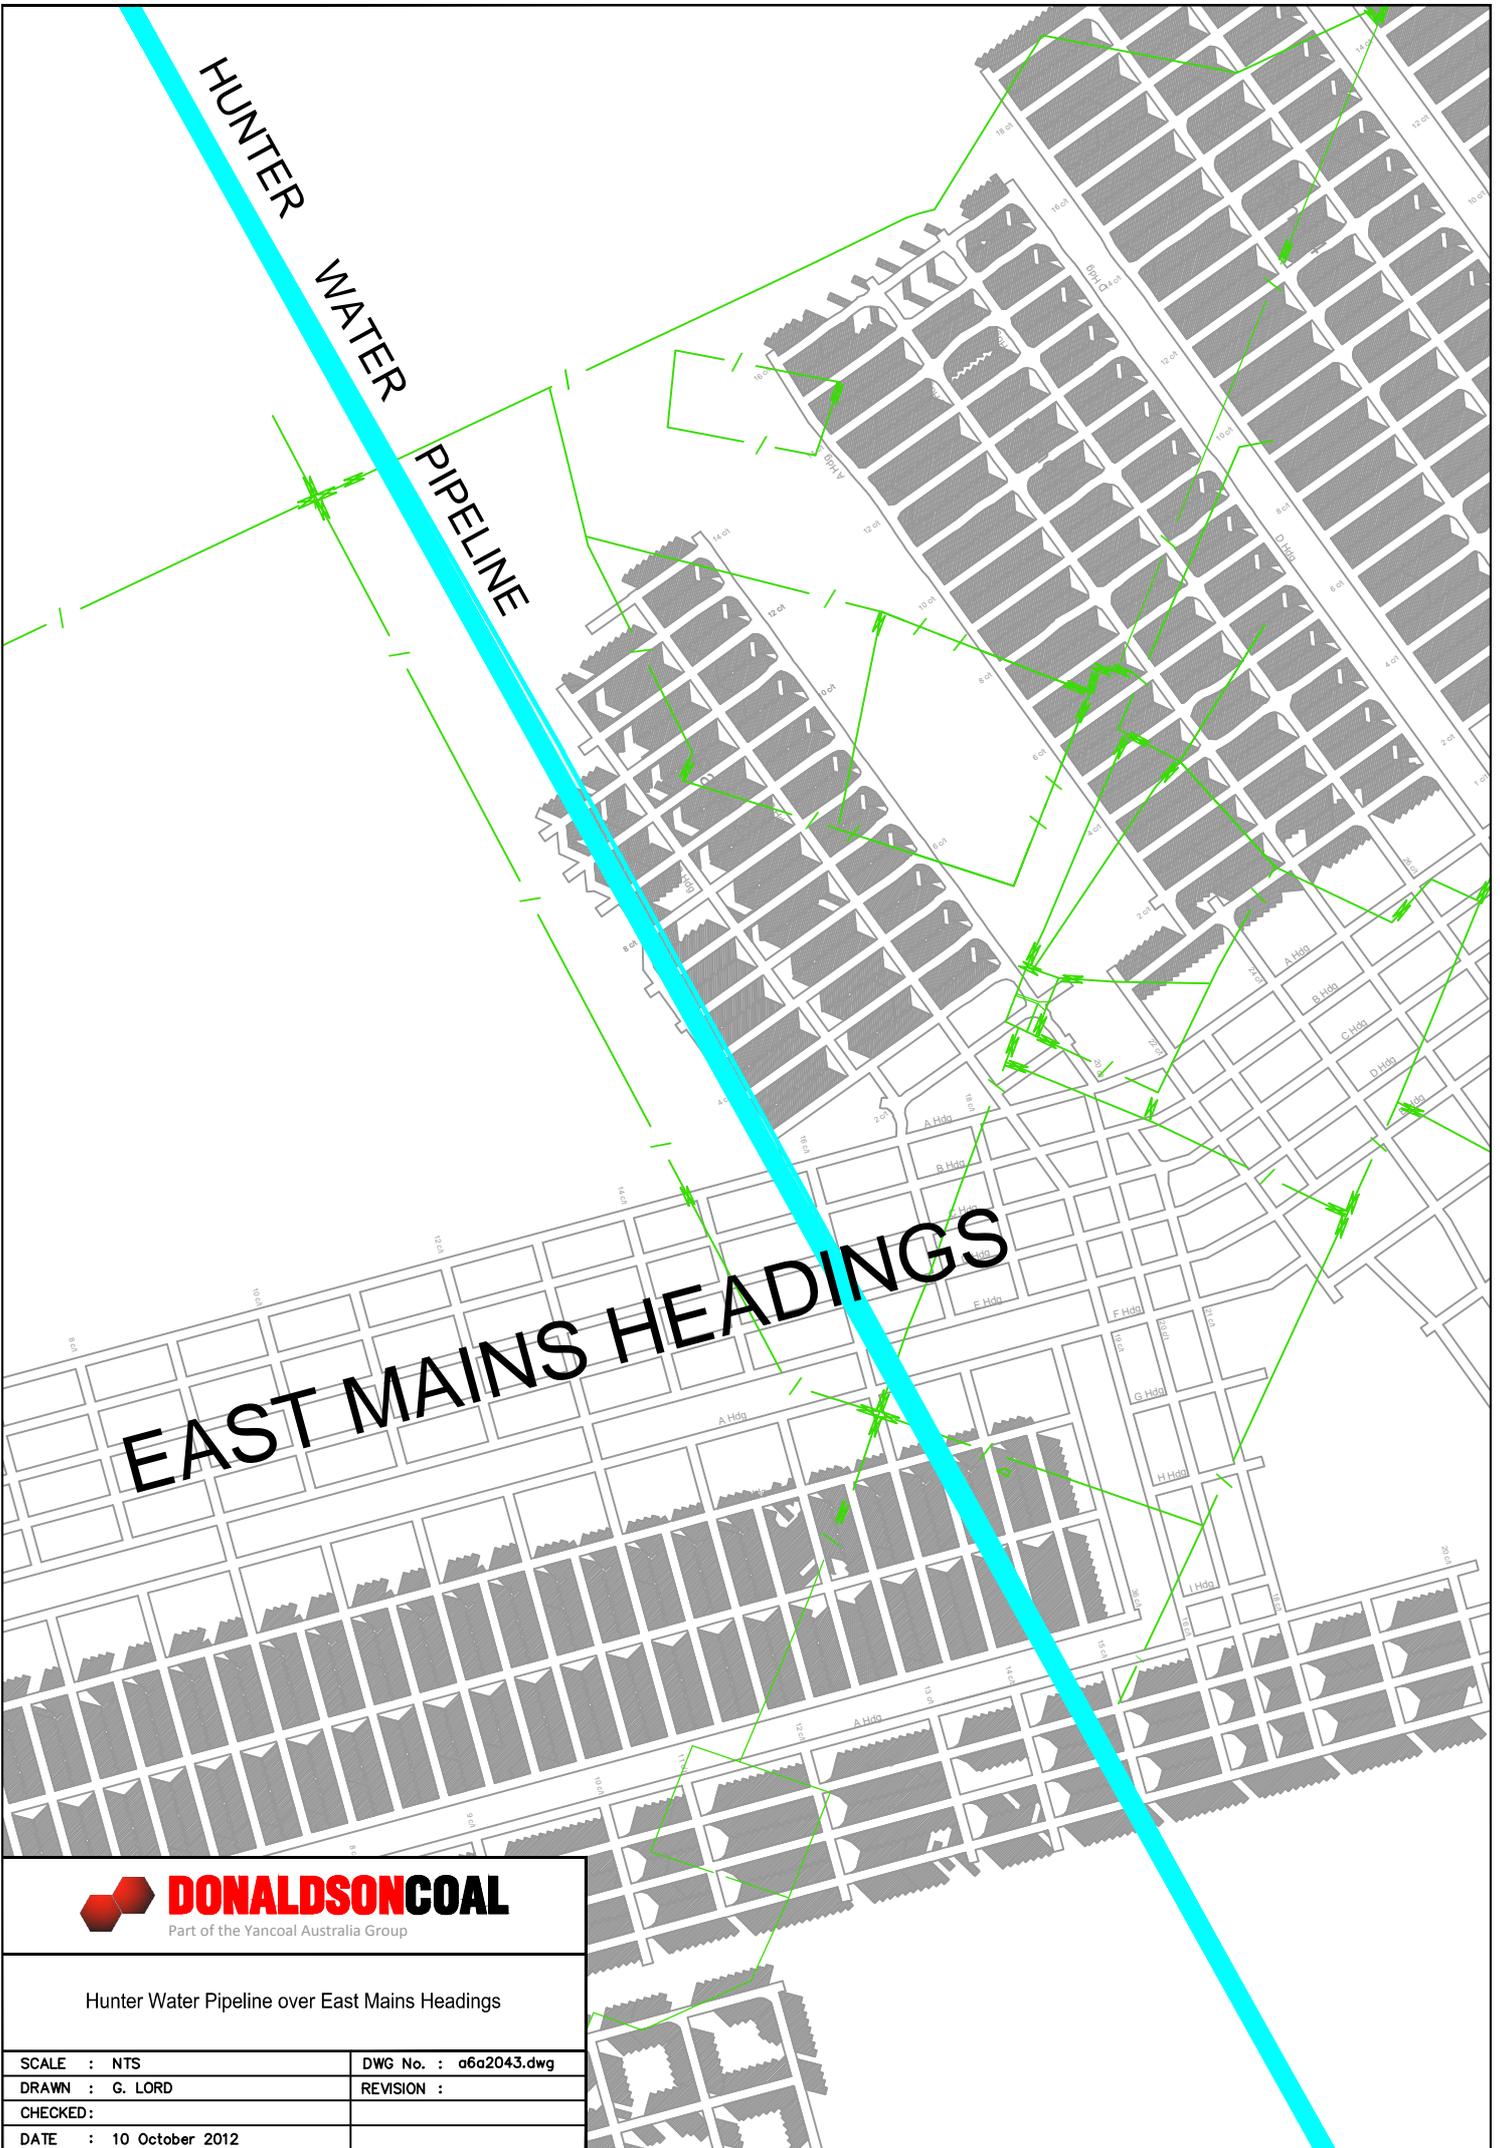
# EAST MAINS HEADINGS

# HUNTER WATER PIPELINE
