**Donaldson Coal**  
**Abel Mine**  
**SMP STAKEHOLDER MEETING**  
**ABEL SMP AREA 2**

9 September 2010

# Abel Mine SMP Area 2

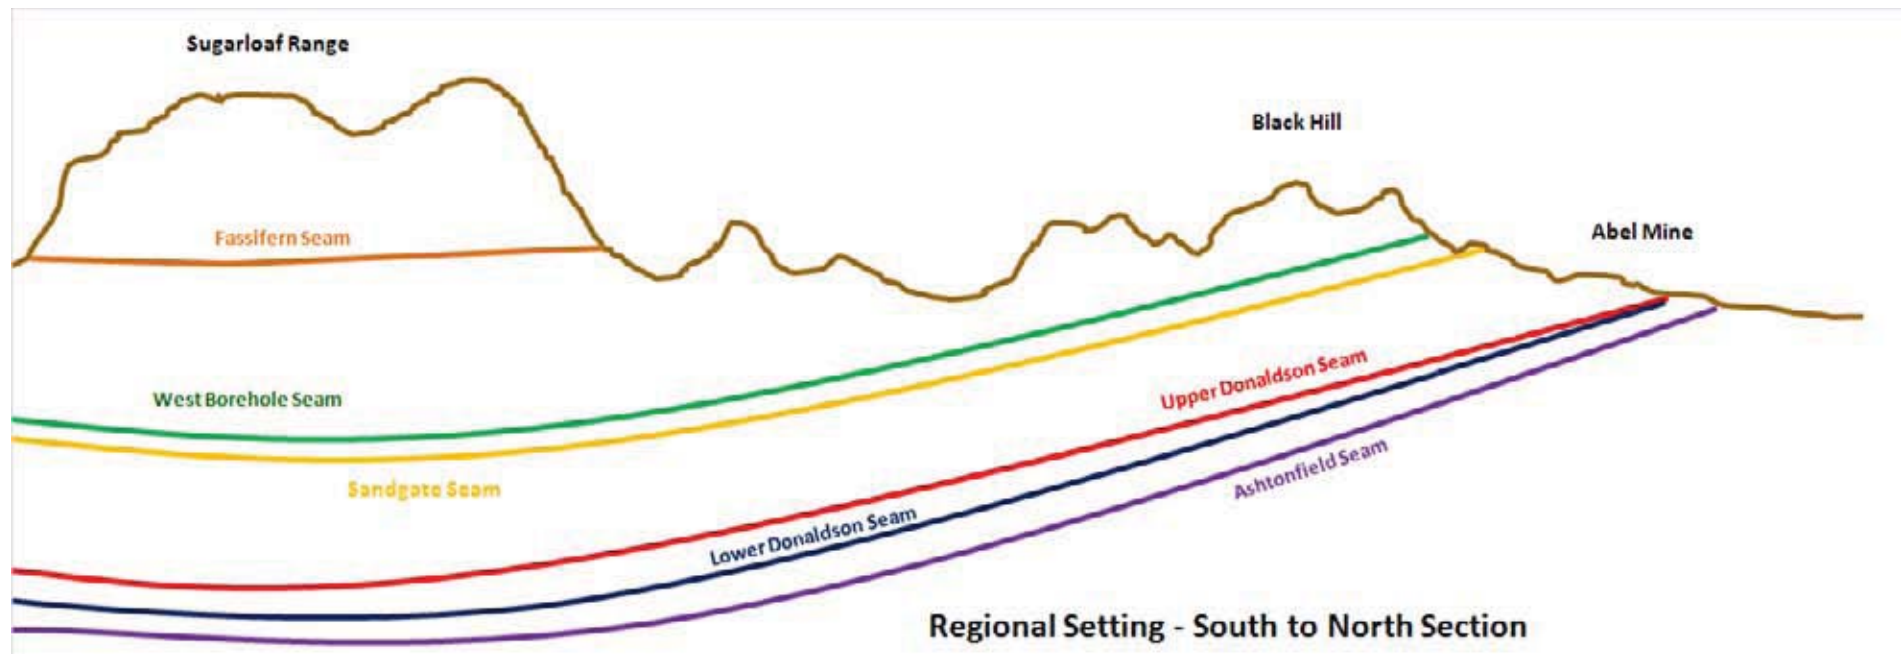
# Geological & Mining Setting

- Target seams are part of the East Maitland/Tomago district Four Mile creek formation
- Seams dips to south

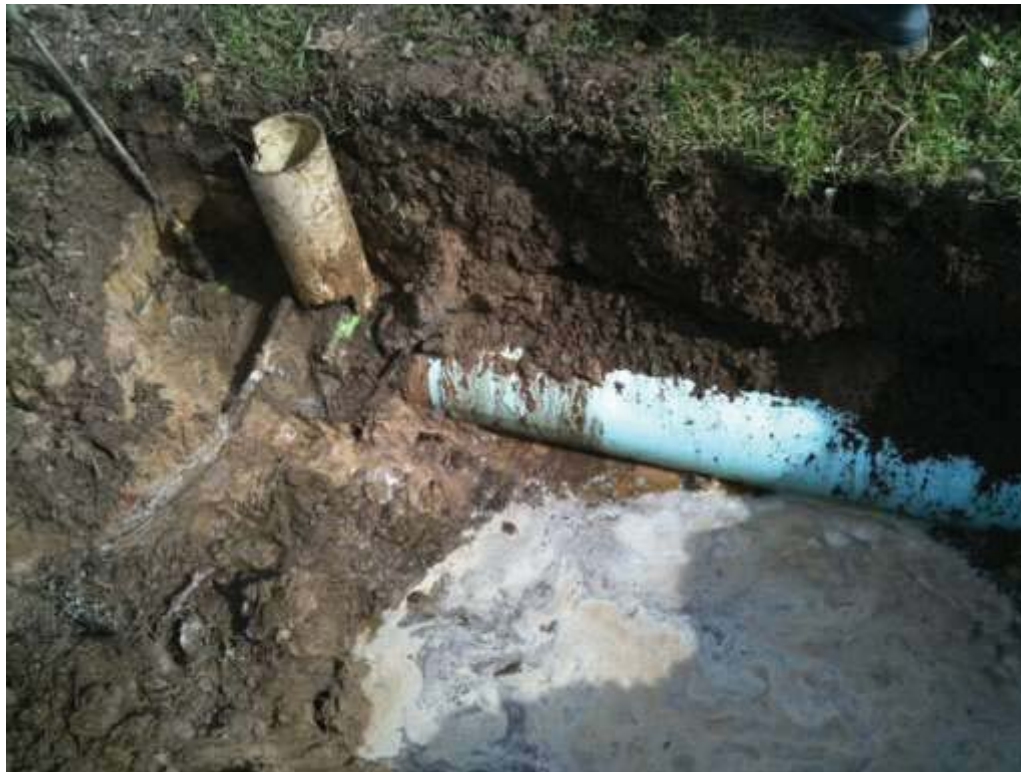
# Cracking on fitting HWC Water Line

- ❖ No Damage to 200mm Line, however leak resulting from cracking of disused copper connection to old 375mm Water Line

Panel	Impacts	SMP Prediction For 156m wide Panel	Actual Impacts to date For 120m wide Panel
Panel 1	Surface cracking	100-150mm	180-200mm across road only (remediated)
	Water Line (HWC)	Potential to be assessed by HWC	Minor crack on fitting fed from the HWC 200mm line (remediated in accordance with HWC MP)
	Power Line (EA)	Potential for clearance loss was identified	Clearance loss on EA 415V line was observed and EA notified (remediated in accordance with EAMP)

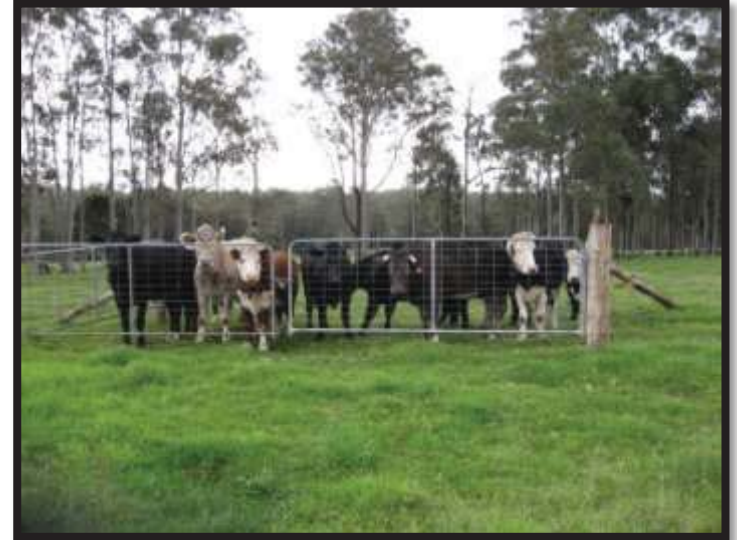
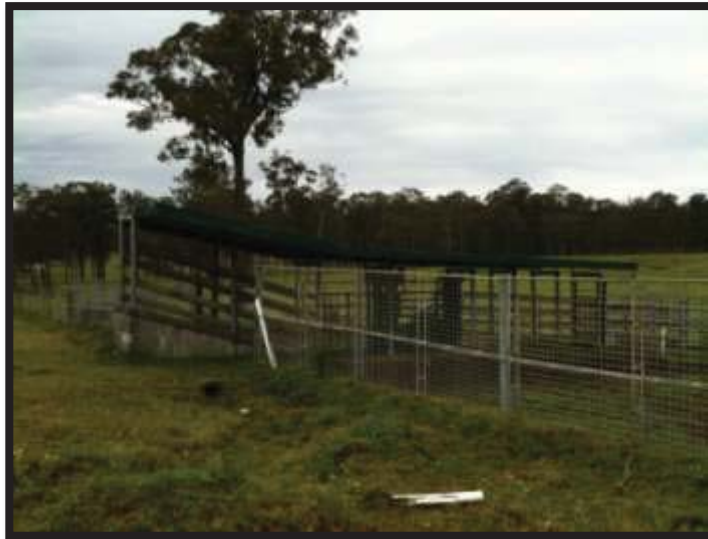
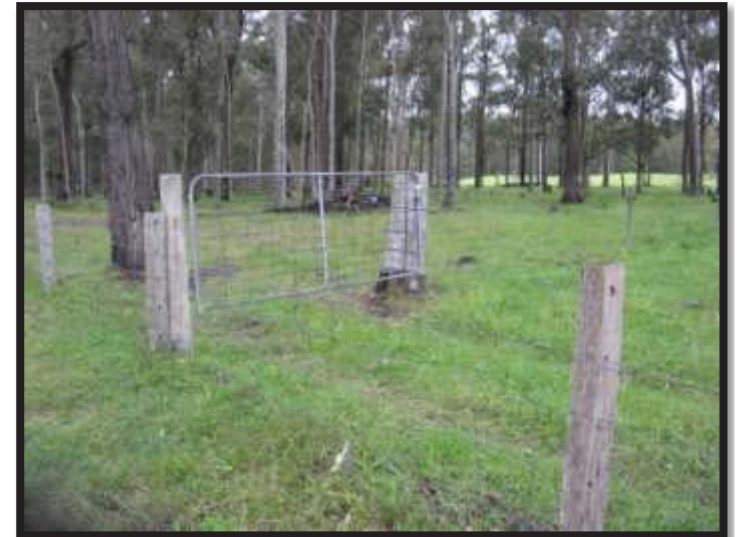
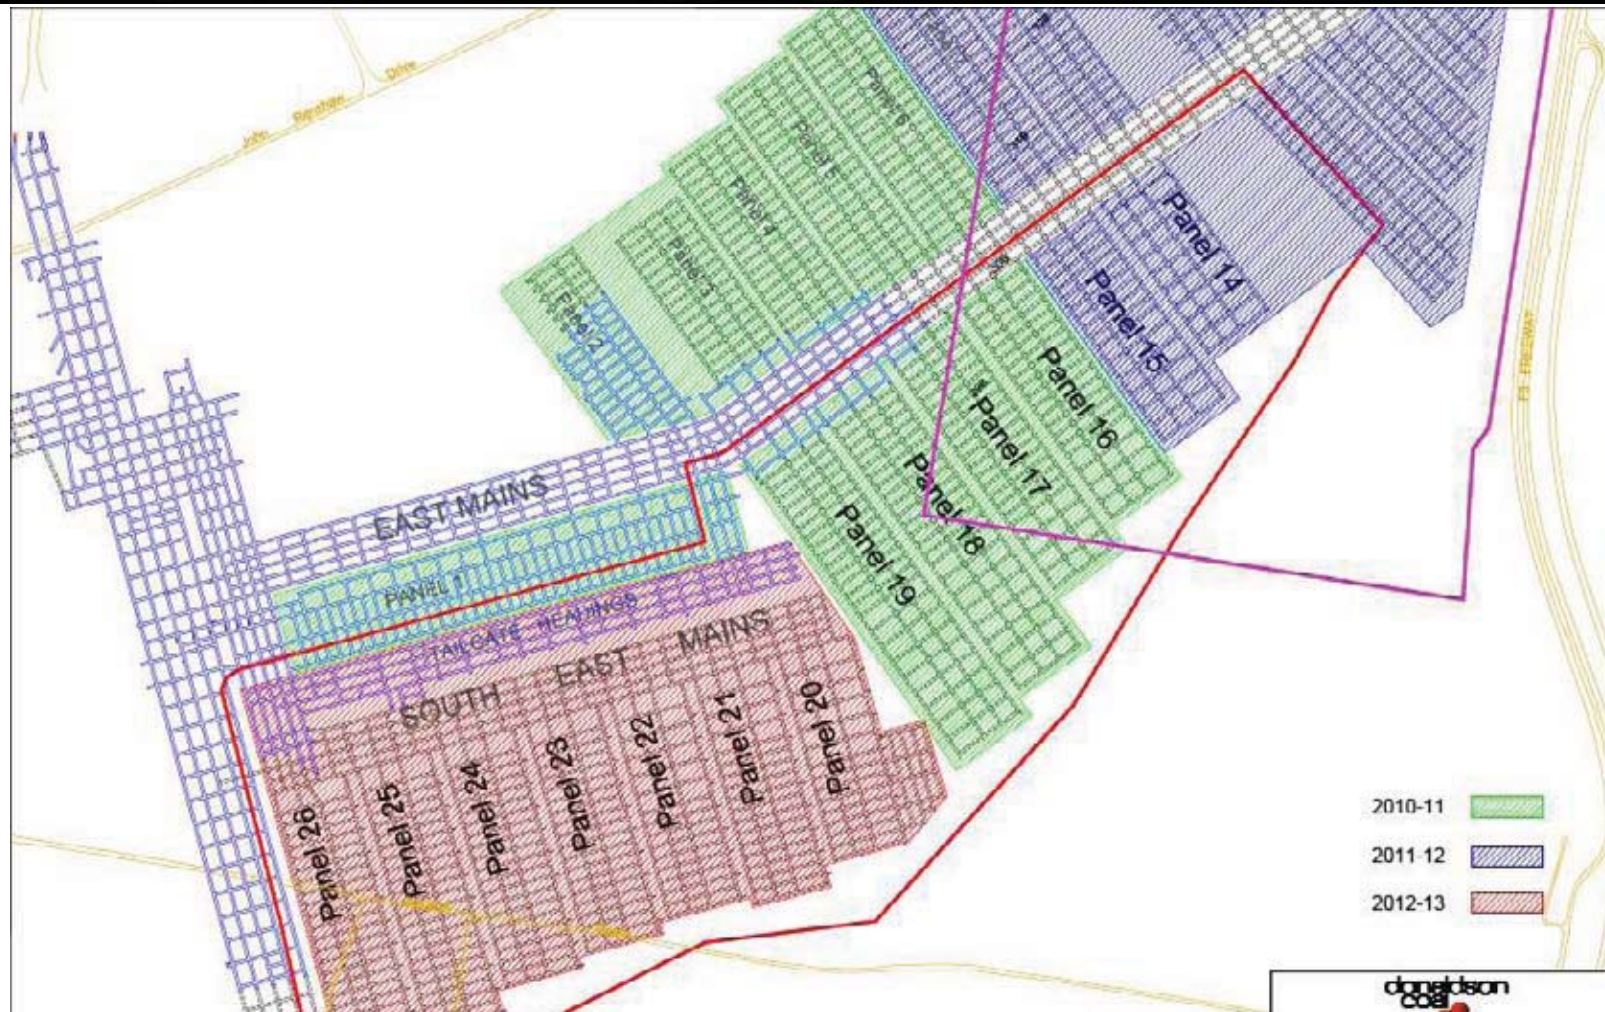
# Catholic Diocese Land

- ◆ Irrigation system for cattle agistment
- ◆ Fences/gates/cattle grids
- ◆ Cattle yards/Holding yards
- ◆ Access tracks
