Water Management Plan

Donaldson Coal

Abel Area 4 Extraction Plan

Surface Water Management Plan

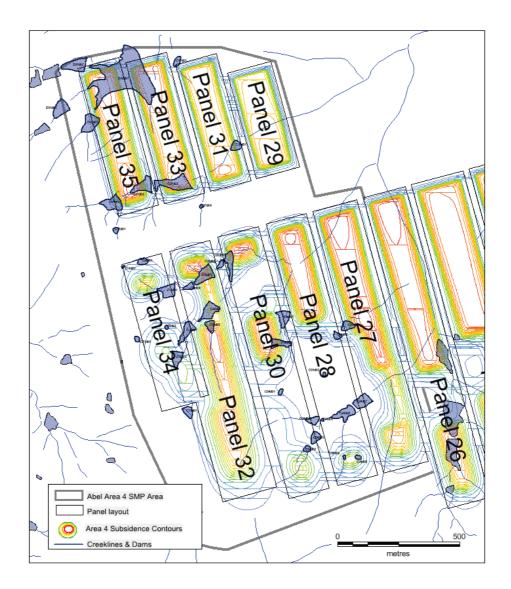
Figure 10: Farm Dams and Subsidence Contours within EP Area 4

The MSEC report also notes that the farm dams located directly above the proposed panels could be subject to strains that could cause cracking, heaving or stepping in the bases or dam walls. In addition there is also a possibility that high concentrations of strain could occur at faults, fissures and other geological features, or points of weaknesses in the strata, leading to a step formation at the surface. If this coincided with a farm dam wall, there is a possibility that cracking in the dam wall or base could occur resulting in loss of the stored water.

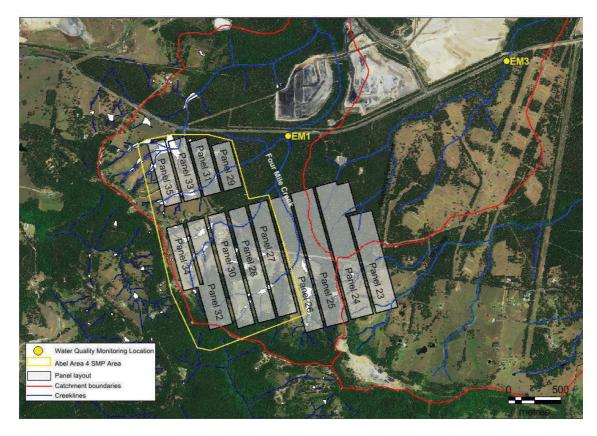
Figure 1: Water Quality Monitoring Locations Downstream of Area 4

Water quality data has been collected on a monthly basis at Weakleys Flat Creek upstream of John Renshaw Drive (about 2 km downstream of Area 3). The location of the Weakleys Flat Creek monitoring station (EM3) is shown on **Figure 1**. Data collection for this site commenced in July 2000, sampling was undertaken for the analytes and parameters detailed in **Table 1**.

Water quality data has been collected on a monthly basis at Four Mile Creek upstream of John Renshaw Drive (about 0.5 km downstream of Area 3) since July 2000. The location of the Four Mile Creek monitoring station (EM1) is shown on Figure 1. Mining commenced within the Four Mile Creek catchment (Abel Area 3, Panels 23 - 26) in July 2013. Therefore, the historical data analysis considers the 144 samples of water quality data collected between July 2000 and July 2013.
