# **Annual Review**

## **Abel Underground Coal Mine**

1 January 2018 – 31 December 2018

R.W. Corkery & Co. Pty. Limited **Geological & Environmental Consultants** ABN: 31 002 033 712

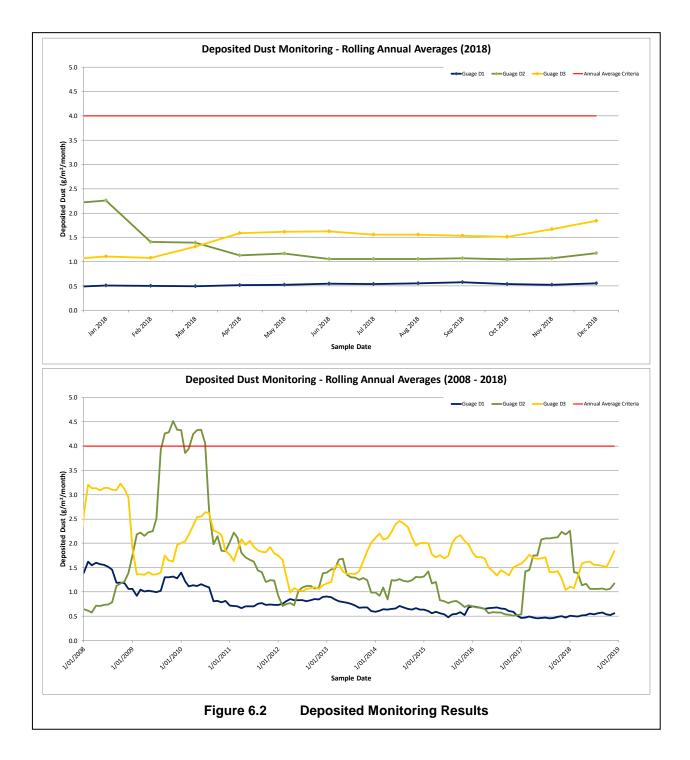
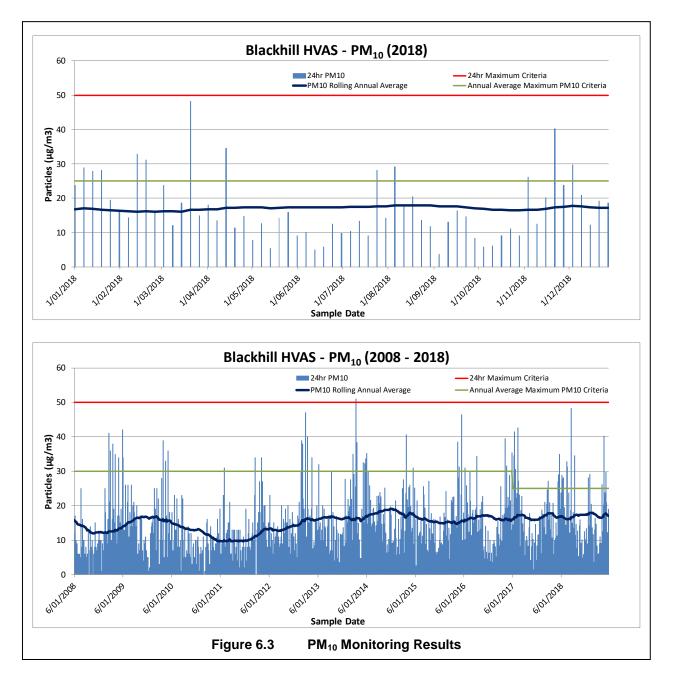
Since commencement of the Abel operations, the rolling annual average deposited dust levels have remained low although spikes are evident due to local events, particularly at sites D2 and D3. However, when accounting for such events, no specific trends are evident and deposited dust levels remain significantly below the annual average criteria.

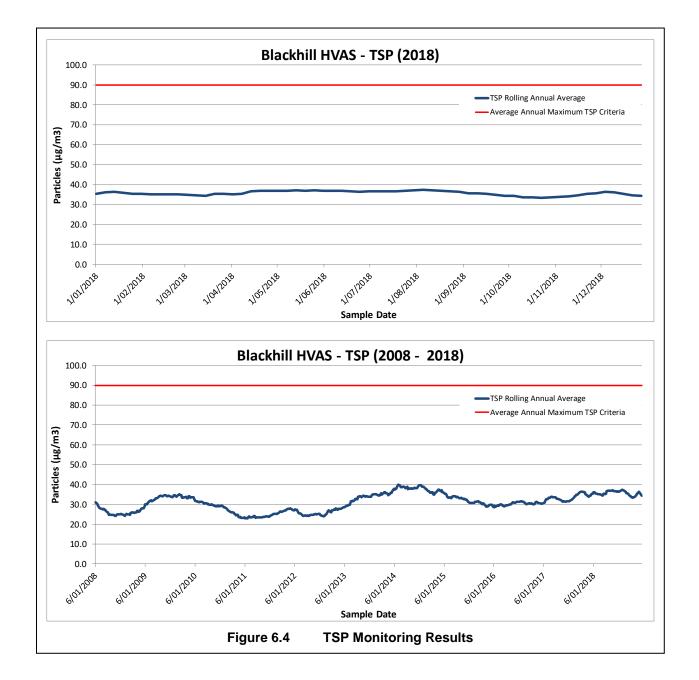
Excepting an annual trend of lower 24-hour average  $PM_{10}$  during the winter months and higher 24-hour averages during the summer months, no long-term trends are currently apparent. Similarly, the rolling annual averages for  $PM_{10}$  and TSP have fluctuated higher or lower by approximately  $5\mu g/m^3$  (see **Figure 6.3** and **6.4**). However, the annual averages remain very similar to the long-term averages (from 6 January 2008) of  $15.2\mu g/m^3$  and  $31.2\mu g/m^3$  respectively.

The suspended particulate monitoring results show that the highest 24-hour average  $PM_{10}$  concentration was  $48.3 \mu g/m^3$ , measured on 20 March 2018, which is below the  $50 \mu g/m^3$  24-hour *National Environment Protection Measures* (NEPM) goal.

The annual average  $PM_{10}$  concentration for Blackhill was  $17.1\mu g/m^3$  for the 12 months to 31 December 2018 whilst the annual average TSP concentration was  $34.4\mu g/m^3$ . The annual monitoring results also indicate that suspended particulate concentrations are well below the annual average criteria of  $25\mu g/m^3$  and  $90\mu g/m^3$  respectively.

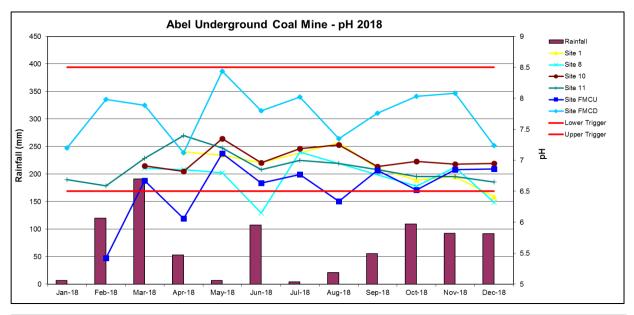
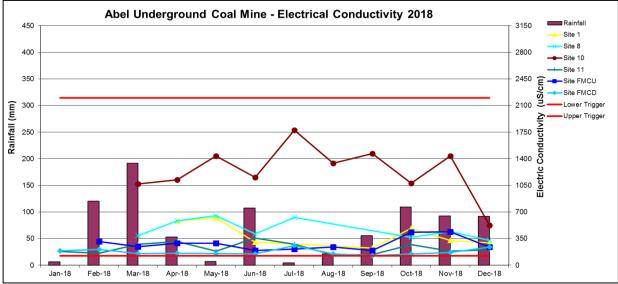
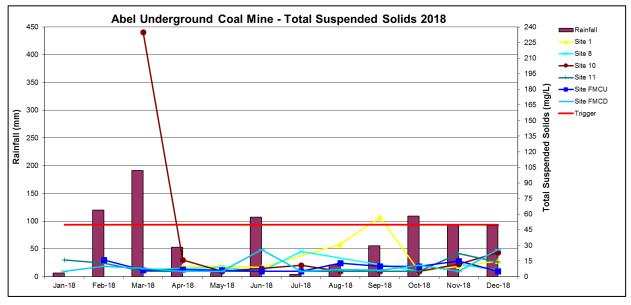
Figure 7.1

Surface Water Quality Monitoring Results – 2018

Surface water monitoring data for the reporting period is summarised in **Table 7.1** and presented graphically in **Figure 7.1** with the full graphical presentation since 2008 presented in **Figure 7.2** and data set provided in **Appendix 2**. It is noted that monitoring at additional sites identified within the Integrated Environmental Monitoring Program incorporating the Abel Mine, Donaldson Mine, and Bloomfield Colliery were undertaken and will be reported within their respective Annual Reviews.

1. Recorded pH values for three of the six monitoring sites fell below the lower pH water quality trigger value (6.5) for Lowland Rivers in NSW outlined in the *Guidelines for Fresh and Marine Water Quality* (ANZECC 2000) on one or more occasions during the reporting period (see **Figure 7.1**). Two of these sites, Site 1 and 8 are upstream of the underground works whilst the third, FMCU, is downstream. Long-term monitoring records a history of short-term declines in pH. Previously, short term declines in pH have followed significant rainfall events (see April 2015 and January 2016 in **Figure 7.2**). However, results which fall below the lower trigger value during this reporting period did not consistently follow significant rainfall events.

Whilst high TSS levels recorded at Site 10 in March 2018 did coincide with the highest monthly rainfall period in 2018 (**Figure 7.1**), historically TSS levels have not coincided with rainfall (**Figure 7.2**) and exceedance at Site 1 in September 2018 did not coincide with a high rainfall period.

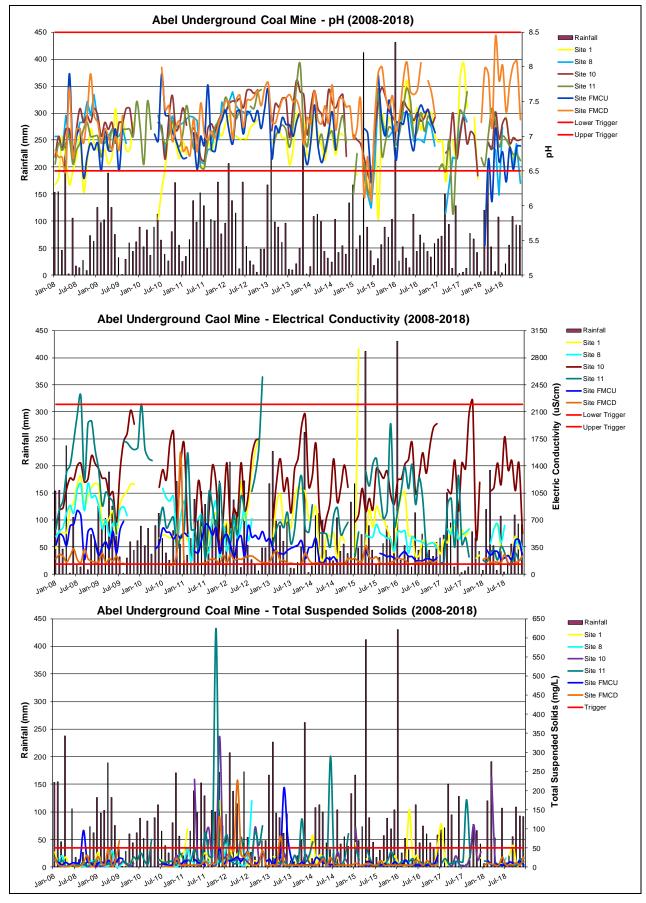
Figure 7.2 Surface Water Quality Monitoring Results – 2008 to 2018

No other long-term trends in pH are apparent (**Figure 7.2**).

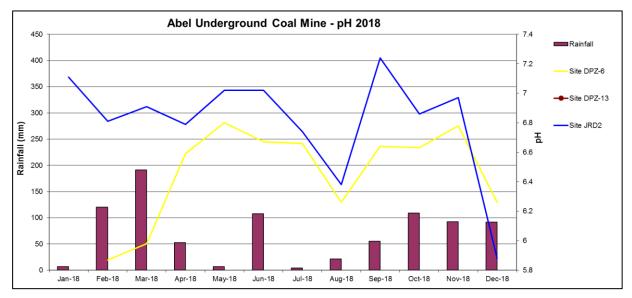
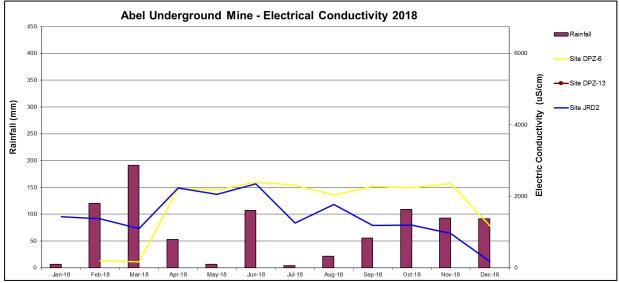
Figure 7.4 Groundwater Quality Monitoring Results – 2018

Groundwater quality monitoring results are presented in **Appendix 2**. A summary of three representative bores located within the Abel underground mine area is presented in **Table 7.2** and **Figures 7.3** with the full graphical presentation since 2008 presented in **Figure 7.4**.

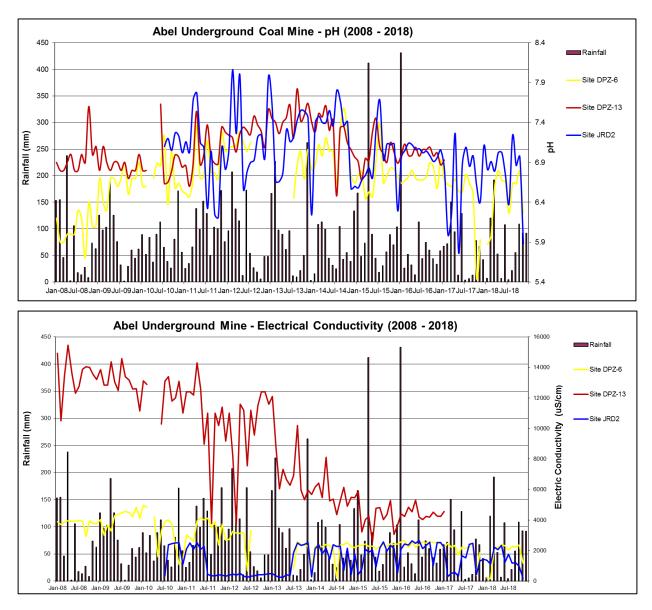
Figure 7.5 Groundwater Quality Monitoring Results – 2008 - 2018

However, a downward trend in EC has previously been observed at bore DPZ13 (Figure 7.4) starting in 2010 / 2011, which may be due to enhanced recharge following drawdowns in the coal measures as a result of mining. Access to DPZ-13 was not available during the reporting period to confirm whether this trend had continued or plateaued. Conversely, EC has been relatively consistent within DPZ-6 and JRD2, monitoring indicates occasional 'outliers' of significantly lower EC. This is likely due to ingress of rainwater temporarily lowering the salinity.
