DONALDSON COAL PTY LTD
ABEL COAL MINE
AREA 2
SURFACE WATER ASSESSMENT
Black Hill, NSW

ABL3 – R1A

5 May, 2011

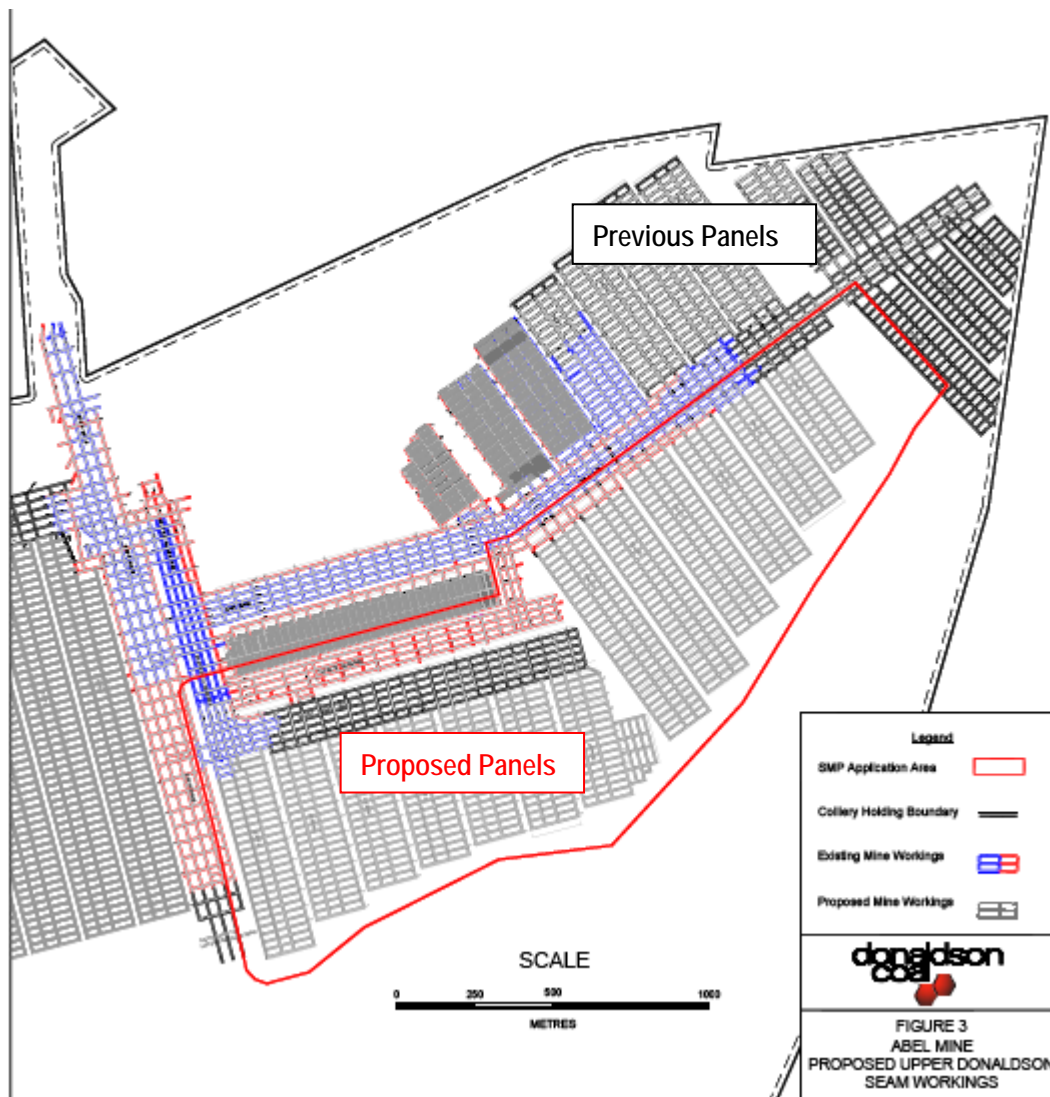
Figure 1 Previously Mined Panels and Proposed Workings

The previously extracted panels are shown in **Figure 1**.

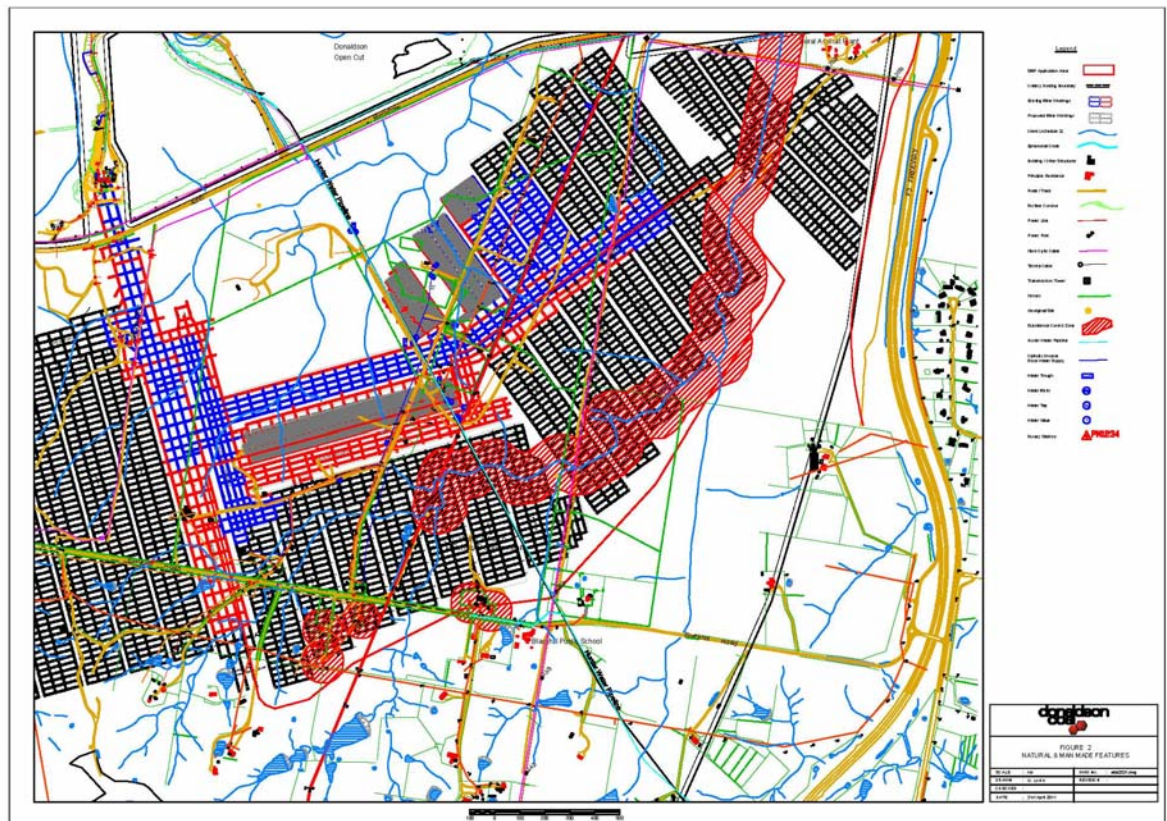
Figure 2 Site Features

The Study Area contains ephemeral catchments draining to the north from Black Hill, with the main Schedule 2 channel of Viney Creek draining to the north north-east as shown in **Figure 2**.

A limited number of small (<1ML) stock watering dams are located within the predicted 20mm subsidence area.

The subsidence area is defined by the cover depths and an angle of draw of 26.5° from the outer periphery of the underground workings to the surface as well as the predicted 20mm vertical limit of subsidence.

Viney Creek is classified as a Schedule 2, 2nd Order stream to the south of Panels 14 – 19 and north of Panels 21 – 26. as shown in **Figure 2**.

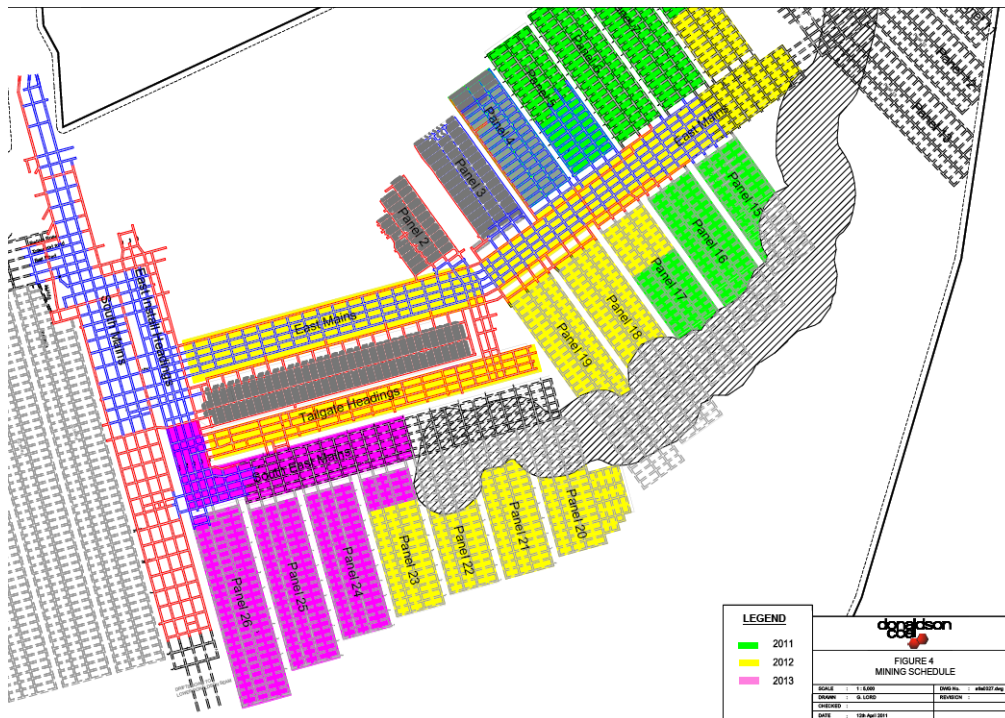
Figure 3 Proposed Panels 14 to 26

Pillar extraction is planned to commence in October 2011, with subsequent mining proceeding to the west through to Panel 26, the South East Mains, Tailgate Headings and East Install Headings as shown in **Figure 3**.

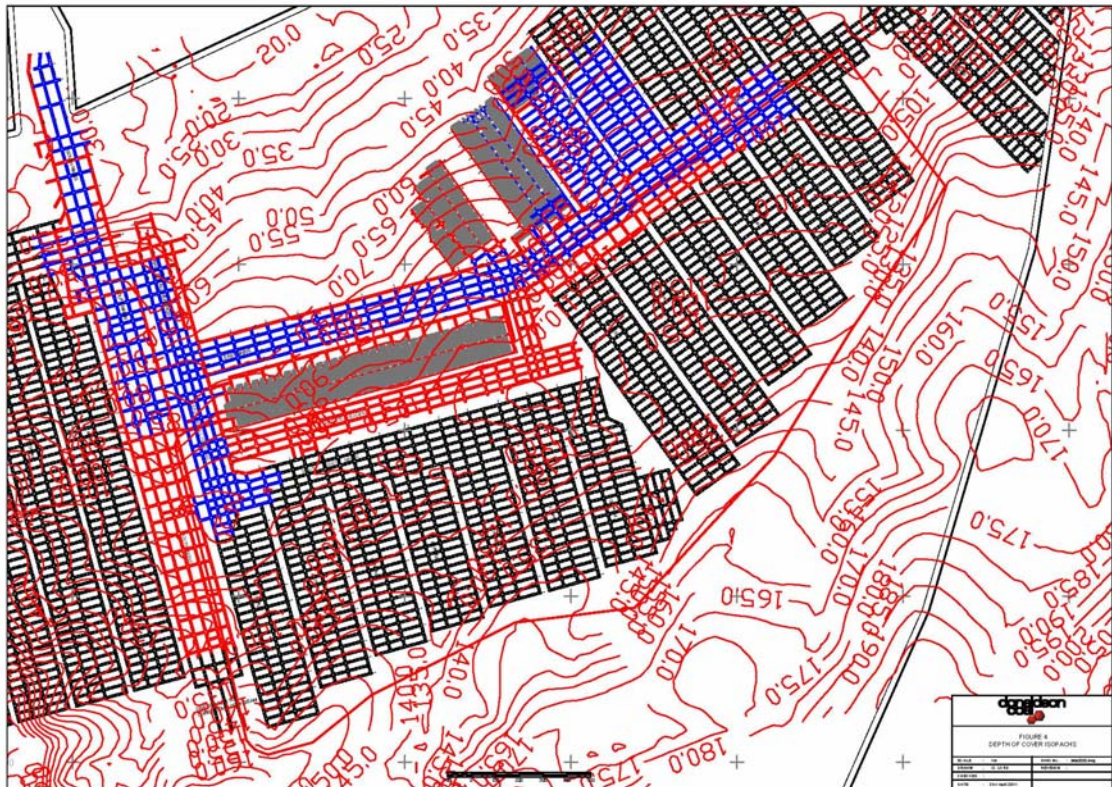
Figure 4 Existing and Proposed Mine Layout and Depth of Cover

The Upper Donaldson Seam is up to 4.2m thick, however the development height is from 2.4 – 2.6m whilst the extraction height ranges from 2.0 – 2.8m, with a depth of cover from 100 – 150m as shown in **Figure 4**.

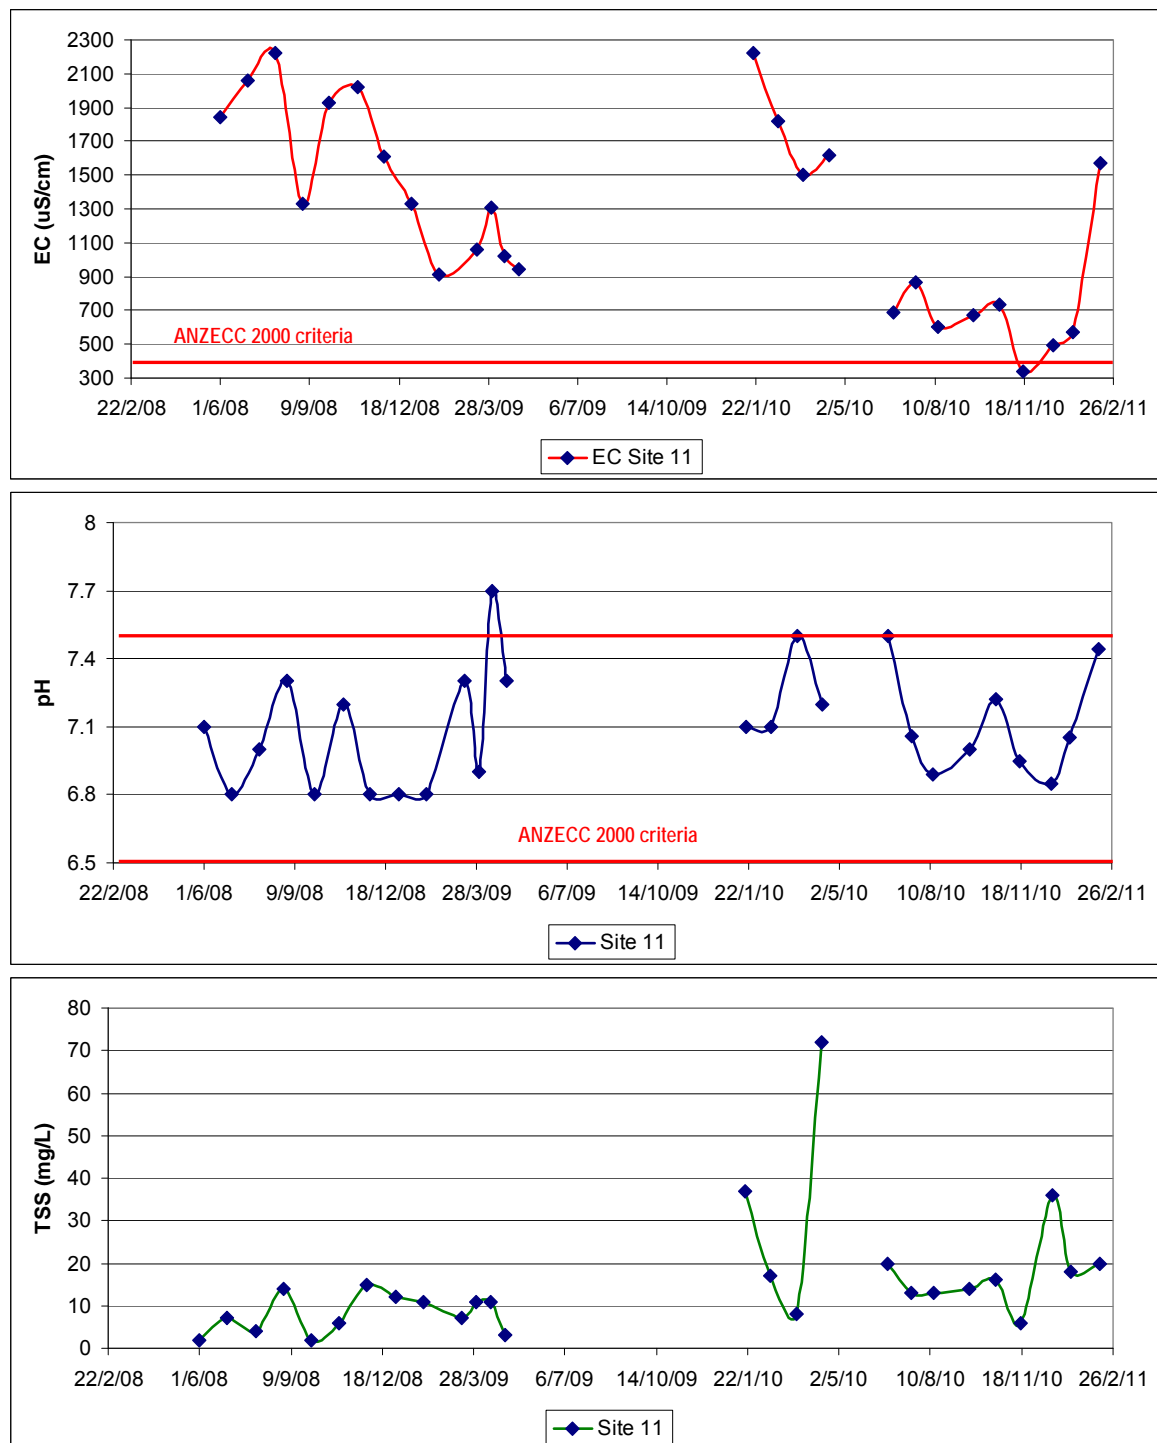
Figure 5 Viney Creek Salinity, pH and Total Suspended Solids

As shown in **Figure 5**, water quality is highly variable with lower salinities and circum-neutral pH during periods of high runoff, with higher salinities during extended dry periods

Figure 5 indicates that salinity of the creek always exceeds the ANZECC 2000 criteria, whilst pH generally does not, whilst **Table 5** indicates nitrogen and phosphorous nutrients in the creek as well as copper, and occasionally zinc, exceed the ANZECC 2000 criteria.

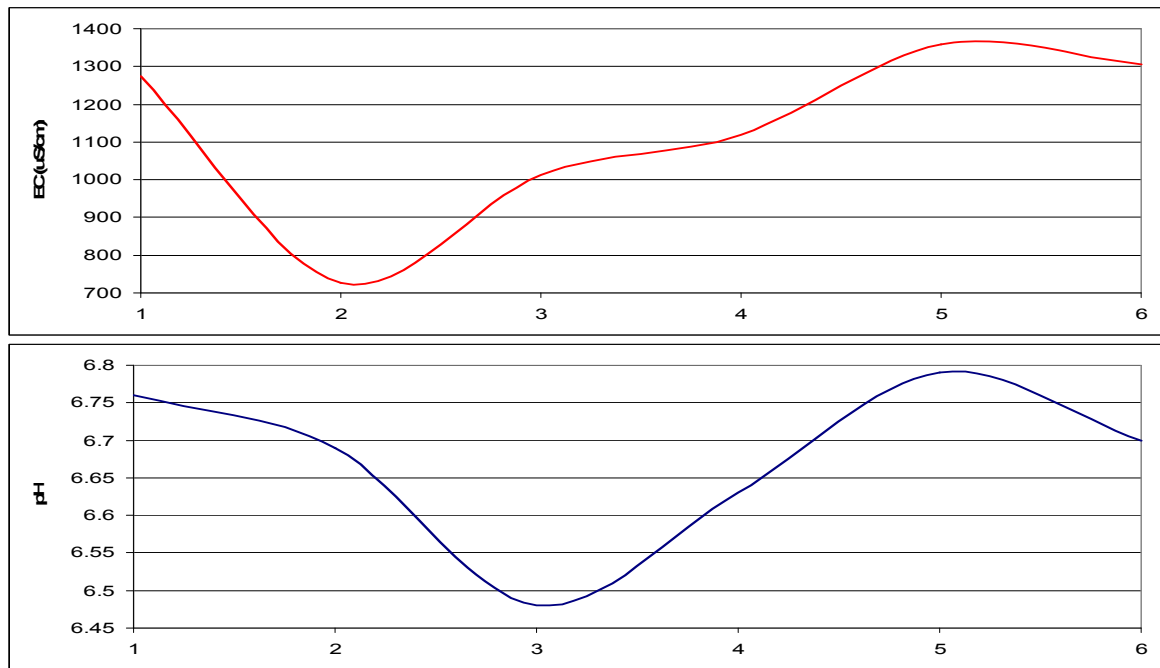
Figure 6 Viney Creek Salinity and pH (31/3/209)

A plot of salinity and pH from upstream to downstream over the proposed Area 2 and existing Area 1 workings in late March 2009 is shown in **Figure 6** from locations shown in **Figure 7**.

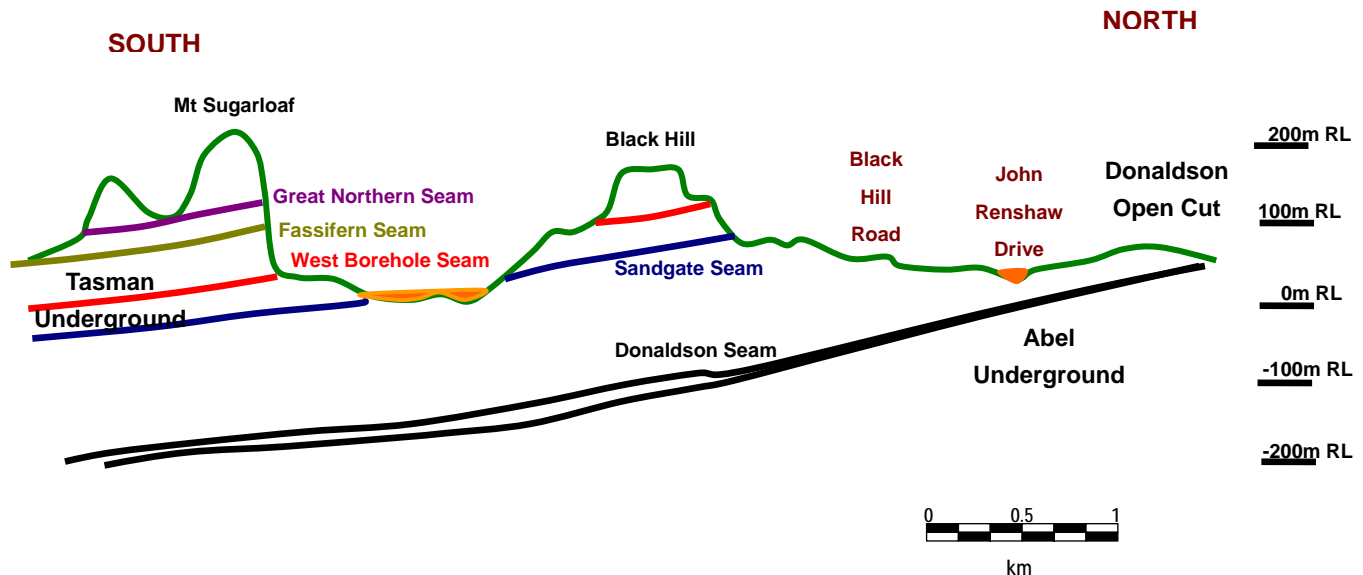
Figure 8 Schematic Geological Cross Section

The Upper Donaldson Seam outcrops in the Donaldson Open Cut area as shown in **Figure 8**. In the proposed mining area, the Upper Donaldson Seam lies within a shallow basinal structure with a gentle plunge to the south.

The overburden consists of gently, south-west dipping (2 – 5°) strata of the Tomago Coal Measures, which generally comprise interbedded sandstone, shale, carbonaceous mudstone, tuffaceous claystone and coal. The coal seams present (in descending order) include the Sandgate, Upper and Lower Buttai, Beresfield, Upper and Lower Donaldson, Big Ben and Ashtonfield Seams.

The generalised stratigraphy of the Tomago Coal measures (after Robinson 1969) is shown in **Figure 8**.

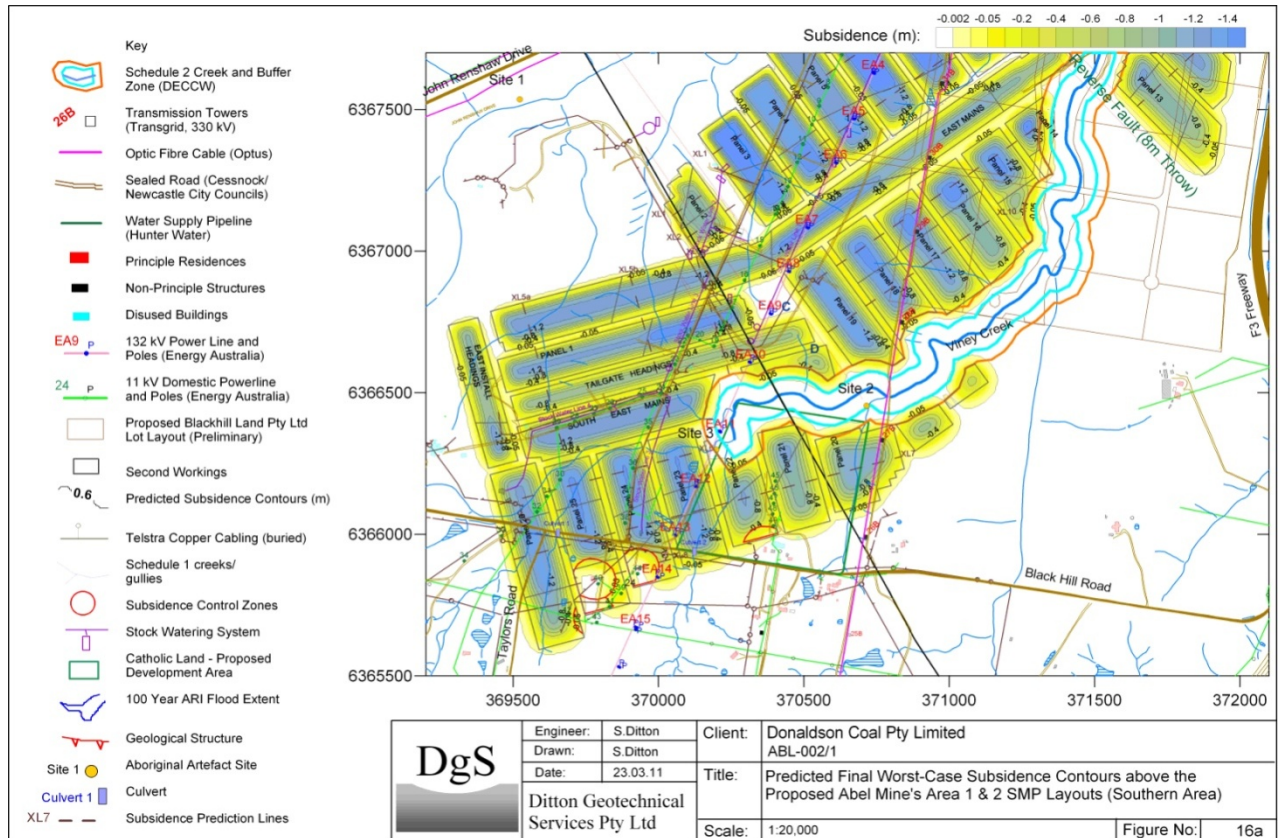
Figure 9 Predicted Subsidence

The predicted subsidence, tilt and strains are illustrated in **Figures 9 to 11**.
