# Donaldson Coal Pty Ltd Abel Underground Mine

# Subsidence Management Plan Area 2 Risk Assessment

Final Report January 2011 HMS973

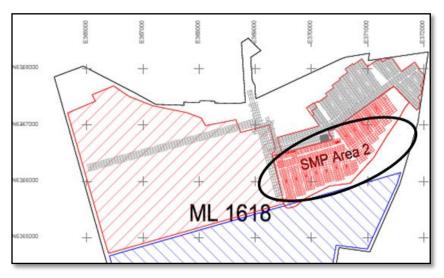
Figure 1 -Subsidence Management Plan Area 2

Subsidence Management Plan Area 2 (SMP Area 2) is delineated by the workings shown in red and labelled SMP Area 2 in *Figure 1 – Subsidence Management Plan Area 2* above. It covers 221 ha. SMP Area 2 represents the current forward plan for Abel until mid 2013, mining the Upper Donaldson Seam only. The Area is divided into 13 panels and 2 areas of Main Headings with a depth of cover ranging from 95m to 150m.
